NASA/CR–2014-218149

PRSEUS Panel Fabrication Final Report

*Kim A. Linton, Alexander Velicki, Krishna Hoffman, Patrick Thrash,
Robert Pickell, and Robert Turley
The Boeing Company, Huntington Beach, California*

January 2014

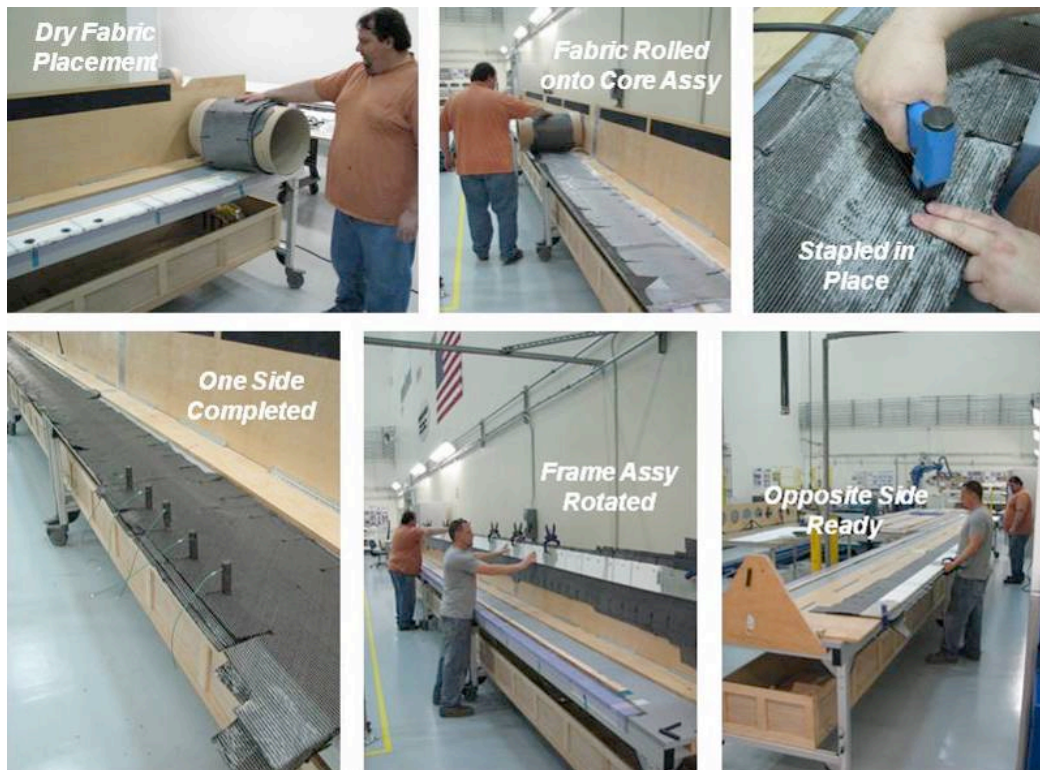
Figure 20. Wooden Assembly Tool Used to Attach Fabric to Foam Core

Next, the pre-cut warp-knit fabric was rolled out onto bonded core subassembly and then stapled into place (Figure 20). A wooden frame assembly tool was used to locate the fabric relative to the core, and then used to flip the frame over to attach the fabric on the other face.

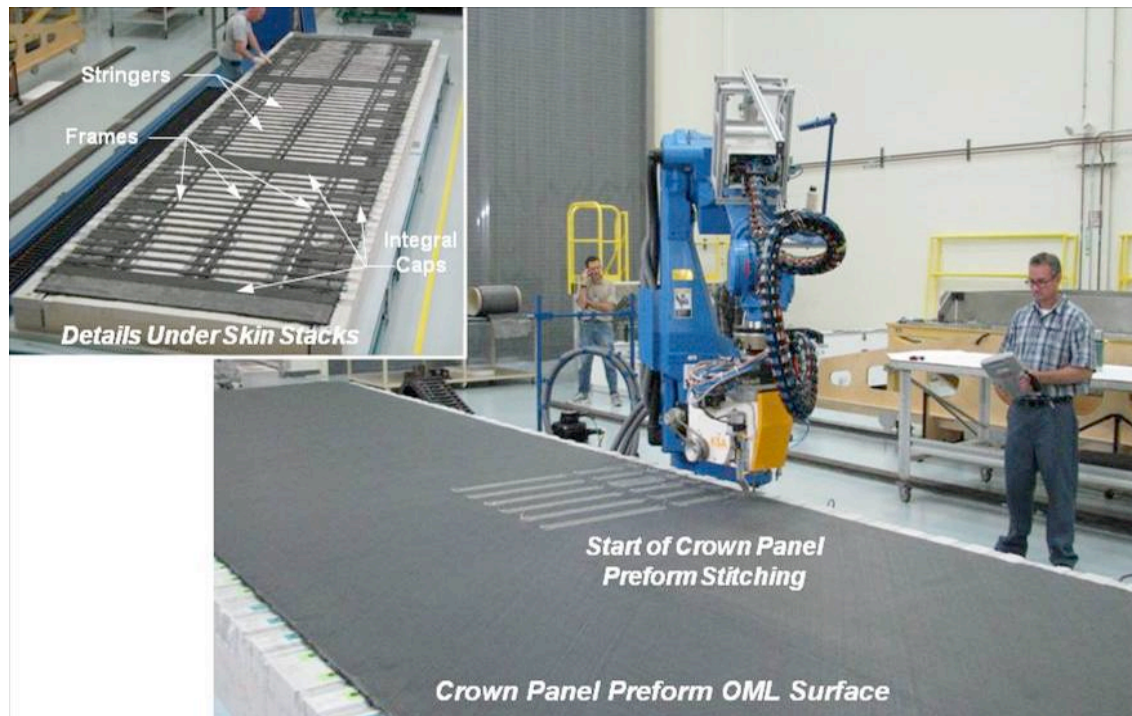
Figure 25. Single-Sided Stitching of Crown Panel Preform Started

Finally, using one-sided stitching technology, the two needle system was used to form a modified chain stitch. The industrial robot arm gives the end effector six degrees of freedom for stitching in 3-D space. The initial seams were inserted into the preform to attach the frame and stringer flanges to the skin (Figure 25).

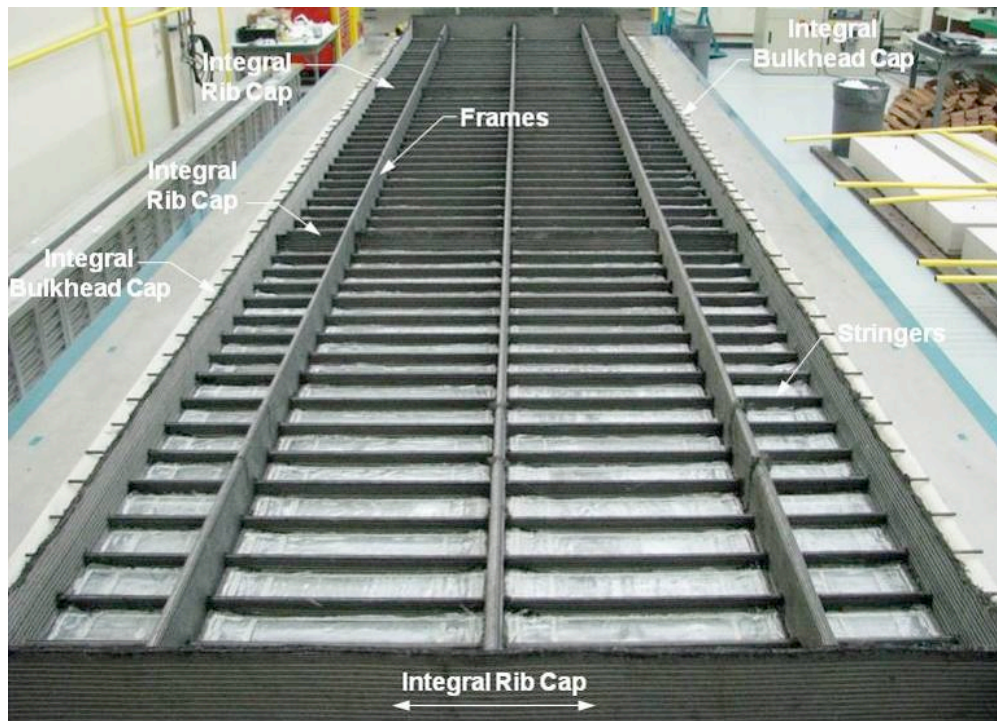
Figure 30. Self-Supporting Crown Panel Preform Placed on the Cure Tool

With the steel base detached, access to the foam blocks and wood picture frame details was now possible. All of the foam blocks and wood frames were easily removed and concerns that the one-piece wood frames might be locked into the preform were not realized. The relative flexibility of the stitched preform was adequate to release the wood frame details without having to pull the rods out. Once these tooling details were removed (Figure 29), only the self-supporting preform remained on the cure tool (Figure 30).

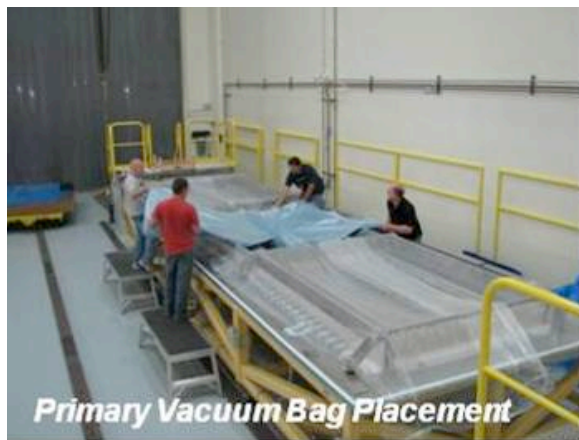
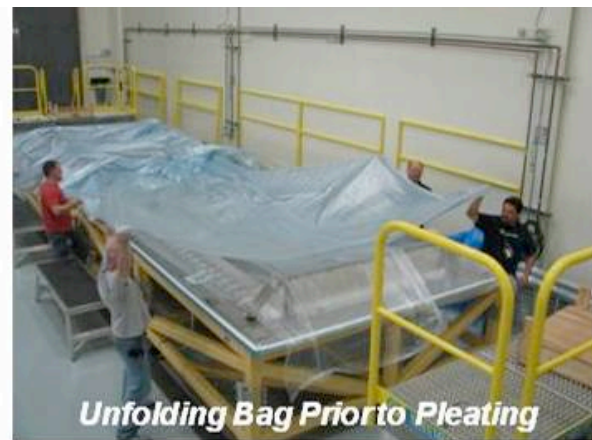
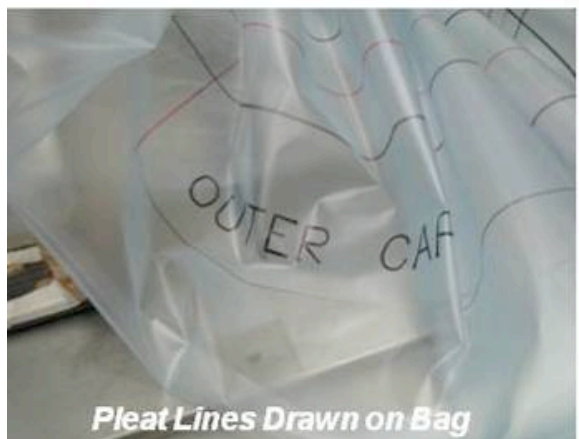
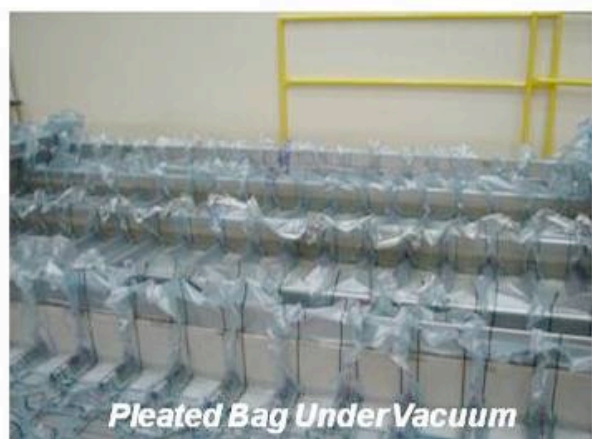
Figure 33. Pleating Operation for Primary Bag Installation

A two bag system is used to seal vacuum the part against the tool. First the primary pleated nylon vacuum bag is draped over the preform, pleated and then sealed down against the OML tool (Figure 33). A secondary textured vacuum bag (green bag in Figure 34) was also added to provide a level of safety should any leaks develop in the primary bag.

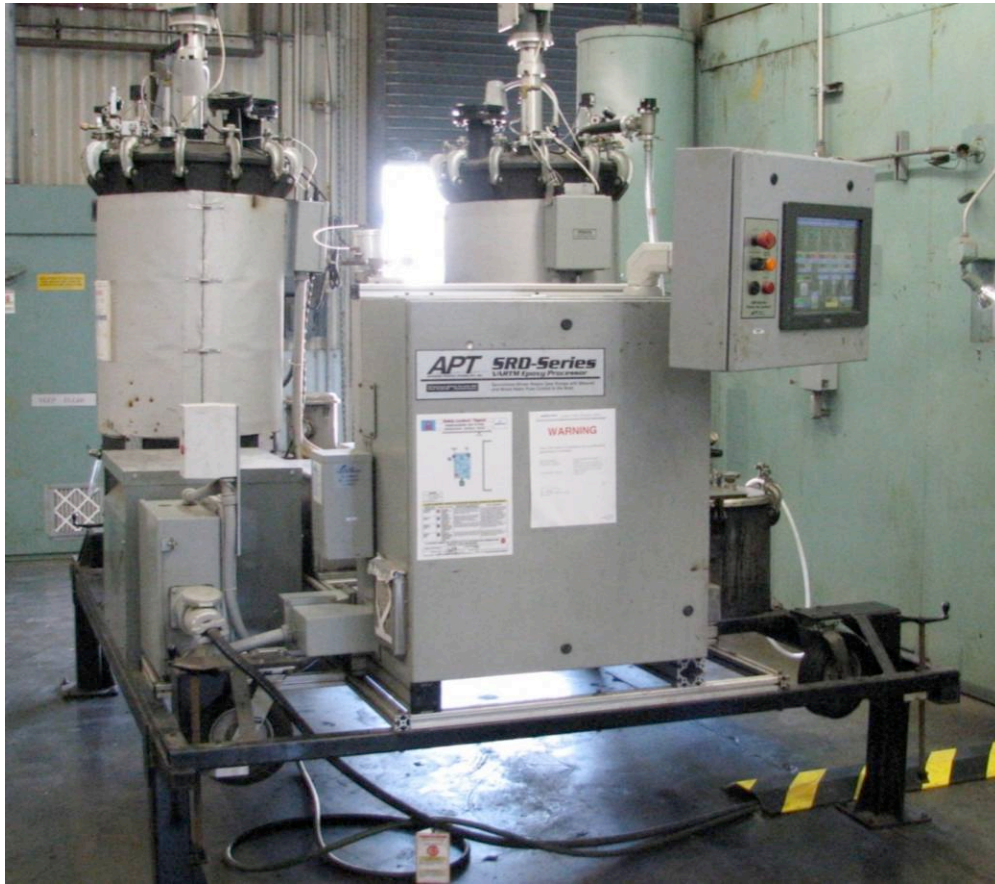
Figure 36. Automated Infusion Equipment Used for Resin Infusion

The 3-D preform was infused using CAPRI process. The resin was a Hexcel two-component amine cured epoxy system known as HEXFLOW VRM34. Resin infusion processing took place with the preform held in a cure tool, which was the only hard tooling required. The preform was infused and cured out. An automated machine was used to prepare and handle the resin (Figure 36). With this machine, the resin and hardener components were kept separated until just prior to entering the part mold fill line. The two components, resin and hardener, were automatically degassed, metered, mixed, and delivered on demand to the mold at the predefined temperature and pressure. The time that the mixed material was at elevated temperature within the machine was reduced to mere seconds, and more importantly, the volume of mixed material is minimized to reduce the chance of an adverse exothermic reaction and clean up time.

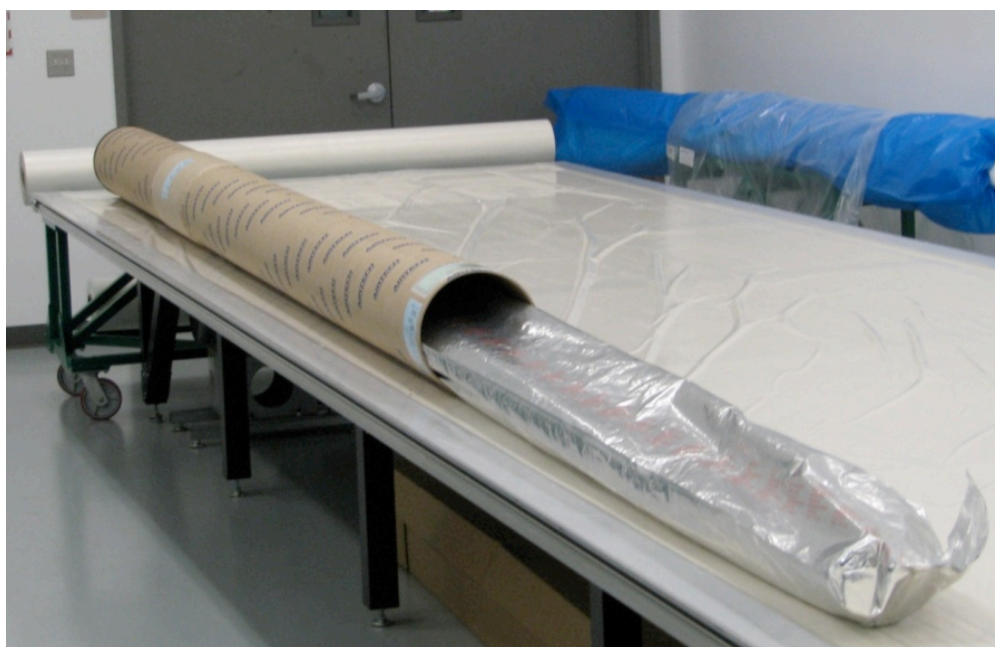
Figure 58. New Pre-Conditioned Vacuum Bag Delivery Packaging

The first step in the new process was to receive the bagging film from the supplier in a rolled and fully moisture-saturated condition, rather than the loosely controlled folded state where high stress concentrations at the double-folded corners were becoming initiation sites for bag cracking. In addition to having the vendor initially steam treat the bags, tighter control of the bag moisture content was also maintained during transport, storage, and the pleating operation on the shop floor. The first new precondition bag and packaging packing system received is shown on the cutting table in Figure 58 prior to use.
